Chip Errata
DSP56156 Digital Signal Processor
 Mask: E25H

ERRATA

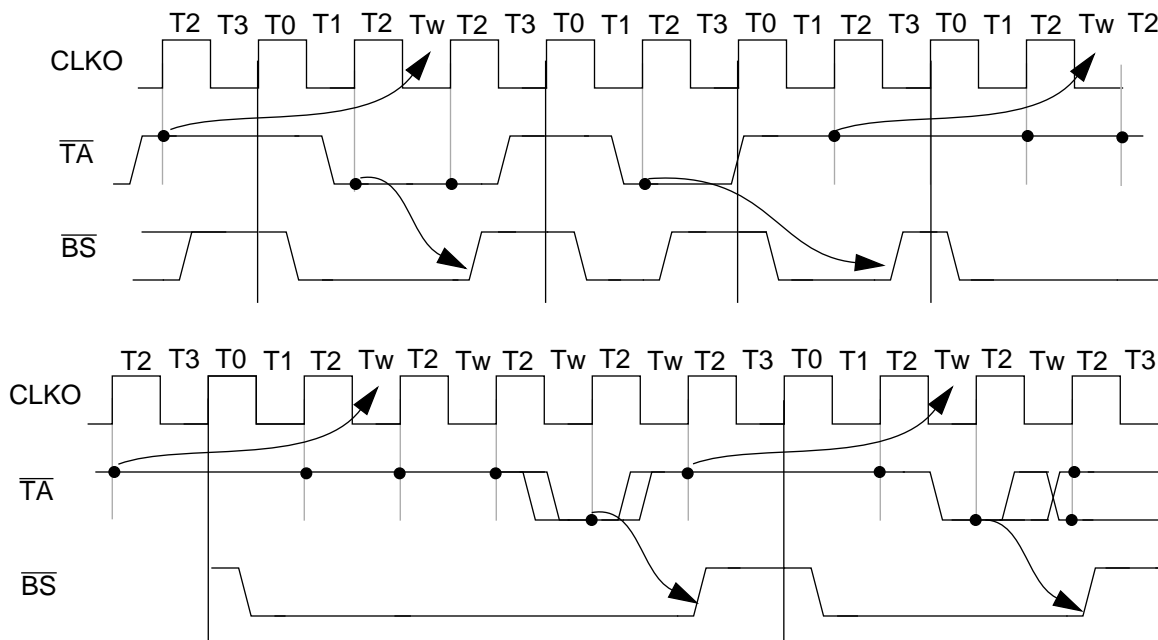
\overline{TA} Controlled Accesses

2. The \overline{TA} pin behavior of this mask set (as well as all previous mask sets) does not match the \overline{TA} definition described in the DSP56156 data sheet (2/1/92). The \overline{TA} behavior is described below; it will be changed to the behavior described in the data sheet in a later revision of the silicon:

\overline{TA} (Transfer Acknowledge) - active low input. If there is no external bus activity, the \overline{TA} input is ignored by the DSP. When there is external bus cycle activity, \overline{TA} can be used to insert wait states in the external bus cycle. \overline{TA} is sampled on the leading edge of T2. Any number of wait states from 1 to infinity may be inserted by using \overline{TA} . If \overline{TA} is sampled high one clock period before the beginning of a bus cycle, at least one wait states will be inserted in the bus cycle. The bus cycle will end 4T after the \overline{TA} has been sampled low on a leading edge of the clock, if the Bus Control Register (BCR) value does not program more wait states. The number of wait states is determined by the \overline{TA} input or by the BCR, whichever is longer. \overline{TA} is still sampled during the leading edge of the clock when wait states are controlled by the BCR value. In that case, \overline{TA} will have to be sampled low during the leading edge of the last wait state programmed by the BCR (4T before the end of the bus cycle programmed by the BCR) in order not to add any wait states. If \overline{TA} is sampled low (asserted) at the leading edge of T2 preceding the bus cycle, and if no wait states are specified in the BCR register, zero wait states will be inserted in the external bus cycle.
