Chip Errata
DSP56156 Digital Signal Processor
 Mask: E69A

ERRATA

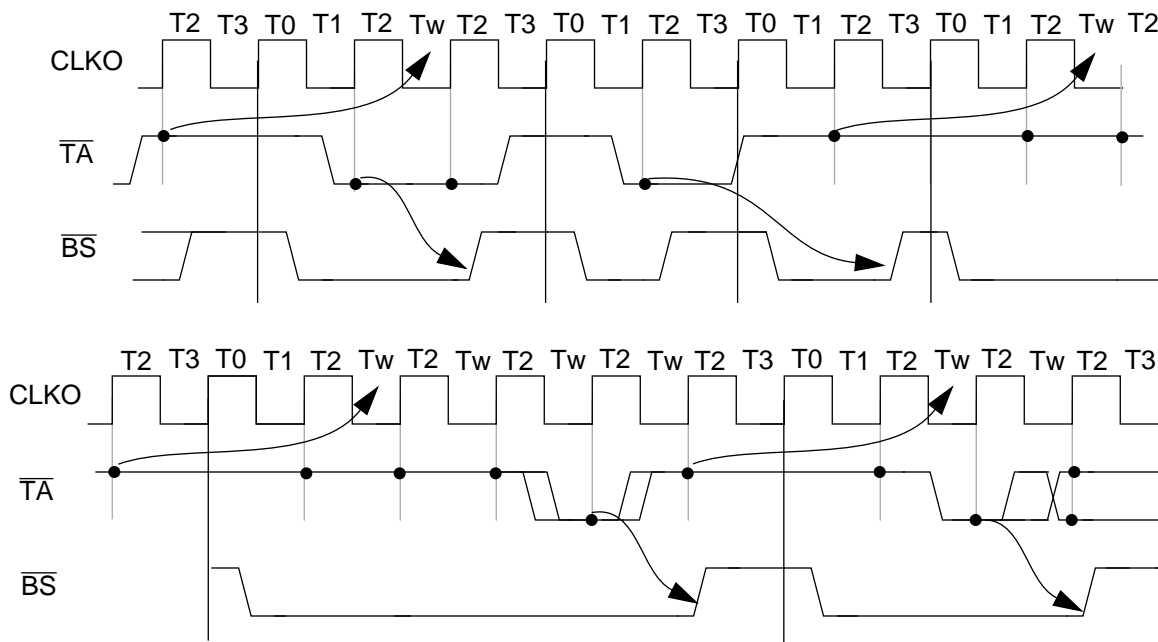
\overline{TA} Controlled Accesses

4. The \overline{TA} pin behavior of this mask set (as well as all previous mask sets) does not match the \overline{TA} definition described in the DSP56156 data sheet (2/1/92). The \overline{TA} behavior is described below; it will be changed to the behavior described in the data sheet in a later revision of the silicon: D13N
D89T
E69A

\overline{TA} (Transfer Acknowledge) - active low input. If there is no external bus activity, the \overline{TA} input is ignored by the DSP. When there is external bus cycle activity, \overline{TA} can be used to insert wait states in the external bus cycle. \overline{TA} is sampled on the leading edge of T2. Any number of wait states from 1 to infinity may be inserted by using \overline{TA} . If \overline{TA} is sampled high one clock period before the beginning of a bus cycle, at least one wait states will be inserted in the bus cycle. The bus cycle will end 4T after the \overline{TA} has been sampled low on a leading edge of the clock, if the Bus Control Register (BCR) value does not program more wait states. The number of wait states is determined by the \overline{TA} input or by the BCR, whichever is longer. \overline{TA} is still sampled during the leading edge of the clock when wait states are controlled by the BCR value. In that case, \overline{TA} will have to be sampled low during the leading edge of the last wait state programmed by the BCR (4T before the end of the bus cycle programmed by the BCR) in order not to add any wait states. If \overline{TA} is sampled low (asserted) at the leading edge of T2 preceding the bus cycle, and if no wait states are specified in the BCR register, zero wait states will be inserted in the external bus cycle.
