Mask Set Errata

MSE912D60P_3L02H
Rev 0, 01/2003

Mask Set Errata for
68HC912D60P
Mask 3L02H

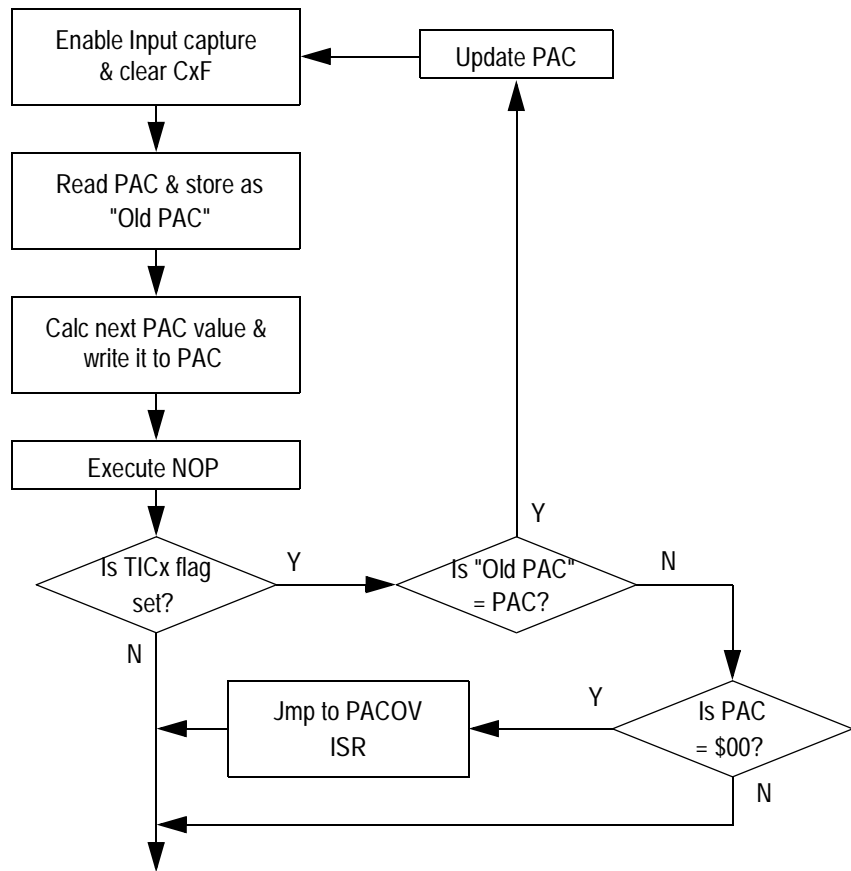
When the value \$FFFF is written to PACA or PACB and, at the same time, an external clocking pulse is applied to the PAC, the pulse accumulator may overflow from \$FFFF to \$0000, but the pulse accumulator overflow flag [PAFLG,PBFLG] is not set. Same situation may happen with 8-bit pulse accumulators PAC1 and PAC3.

The input capture function for the subject channel be enabled prior to writing a value to the PACA or PACB. Write to the pulse accumulator register. Then do one NOP (to allow the input capture to update the interrupt flag) followed by a read of the input capture interrupt flag to see if it set. If yes, a check must be made for a missing pulse accumulator event. Steps for software workaround to see if event happens while writing to PAC:

1. Enable Input Capture on same pin as the pulse accumulator (and same type of event).
2. Clear the appropriate CxF in the timer interrupt flag register.
3. Read PAC and store as "Old PAC".
4. Calculate desired PAC value and write it to the PAC.
5. Execute 1 NOP.
6. Read CxF in the timer interrupt flag register.

If flag is not set, done (no events happened while writing to the PAC).

If flag is set read PAC

If "Old PAC" = PAC, then update PAC (event happened while writing to PAC and the PAC did not capture it). Note, if the updated PAC value is \$00 jump to PACOV ISR.

If "Old PAC" does not equal PAC, does PAC = \$00 ?

If yes, jump to PACOV ISR.

If no, done (event happened while writing to the PAC and PAC captured it). Read CxF in the timer interrupt.
