# Mask Set Errata for Mask 0L78P

This mask set errata applies to the mask 0L78P for these products:

- MC9S08RE16
- MC9S08RE8
- MC9S08RD16
- MC9S08RD8
- MC9S08RC16
- MC9S08RC8

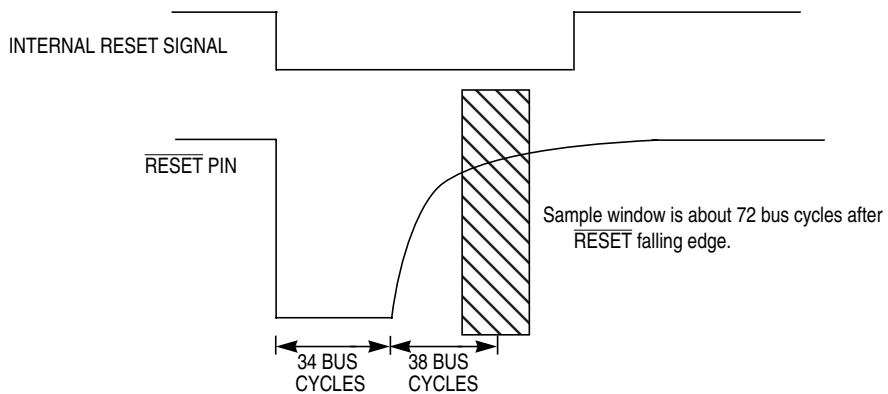
**Case 1** — After detecting a reset signal, either internal or external, the internal reset circuit latches the cause of the reset, forces a low level on the external  $\overline{\text{RESET}}$  pin for about 34 bus cycles, releases the pin, and samples the pin level about 38 bus cycles later.

To avoid multiple edges on the  $\overline{\text{RESET}}$  pin due to switch contact ringing or EMC noise, eliminate any voltage bounce through RC filtering. A 0.1  $\mu\text{F}$  capacitor to ground and an external 4.7 k $\Omega$  to 10 k $\Omega$  resistor to  $V_{DD}$  works well to ensure noise suppression.

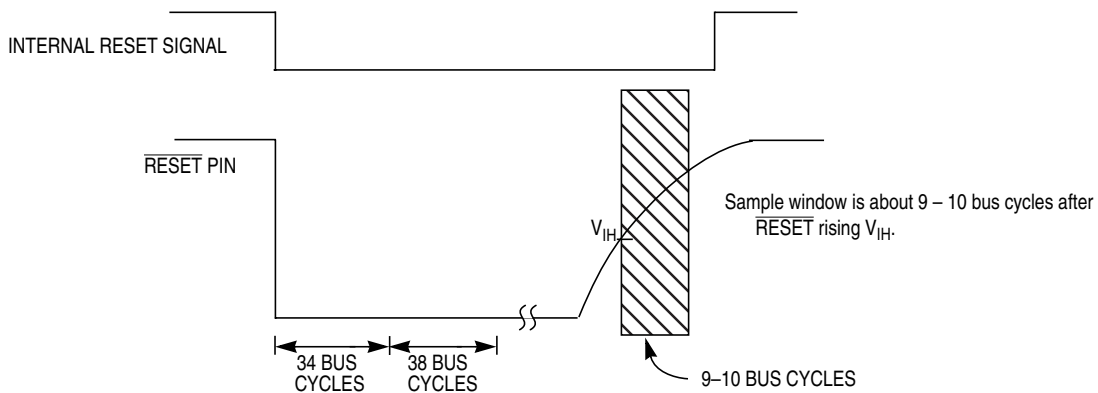
**Case 2** — After remaining in reset for an extended period of time due to an externally applied low level on  $\overline{\text{RESET}}$ , the internal reset circuit will sample the pin level about 9 to 10 bus cycles after the pin raises above its  $V_{IH}$  level.

In addition to RC filtering, avoid spurious edges on the  $\overline{\text{RESET}}$  pin caused by external active circuitry such as low voltage detectors and watchdog components. Do this by ensuring that external circuitry cannot drive  $\overline{\text{RESET}}$  low within 10 bus cycles of the release of  $\overline{\text{RESET}}$ .
