Mask Set Errata for Mask 0M11F

This mask set errata applies to the mask 0M11F for these products:

- MC9S08RG60
- MC9S08RG32
- MC9S08RE60
- MC9S08RE32
- MC9S08RD60
- MC9S08RD32
- MC9S08RC60
- MC9S08RC32

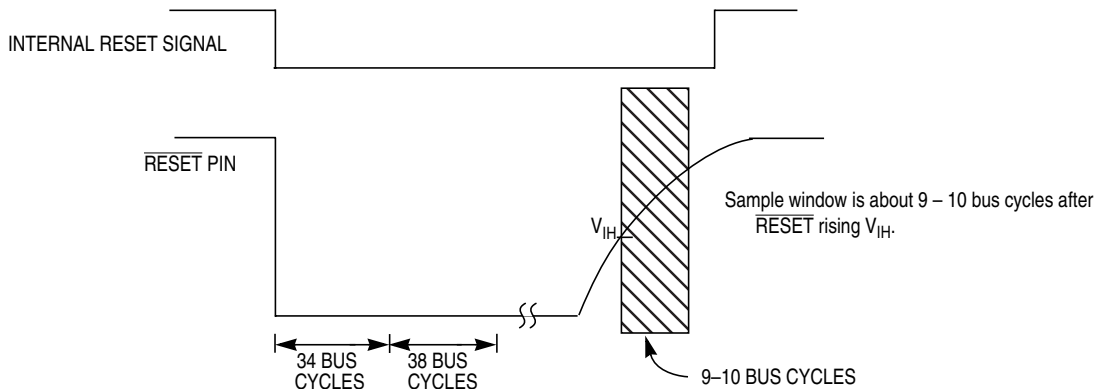
Case 1 — After detecting a reset signal, either internal or external, the internal reset circuit latches the cause of the reset, forces a low level on the external $\overline{\text{RESET}}$ pin for about 34 bus cycles, releases the pin, and samples the pin level about 38 bus cycles later.

To avoid multiple edges on the $\overline{\text{RESET}}$ pin due to switch contact ringing or EMC noise, eliminate any voltage bounce through RC filtering. A 0.1 μF capacitor to ground and an external 4.7 k Ω to 10 k Ω resistor to V_{DD} works well to ensure noise suppression.

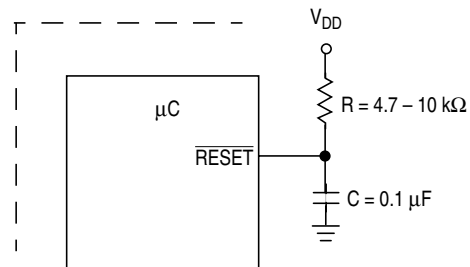
Case 2 — After remaining in reset for an extended period of time due to an externally applied low level on $\overline{\text{RESET}}$, the internal reset circuit will sample the pin level about 9 to 10 bus cycles after the pin raises above its V_{IH} level.

In addition to RC filtering, avoid spurious edges on the $\overline{\text{RESET}}$ pin caused by external active circuitry such as low voltage detectors and watchdog components. Do this by ensuring that external circuitry cannot drive $\overline{\text{RESET}}$ low within 10 bus cycles of the release of $\overline{\text{RESET}}$.
